RUBY DAM

Fact Sheet

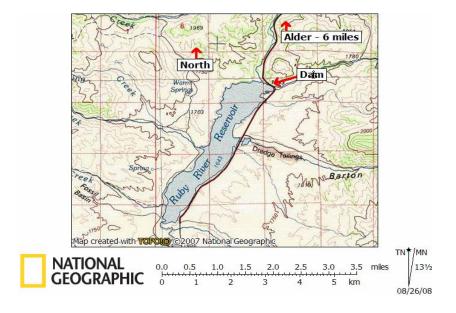
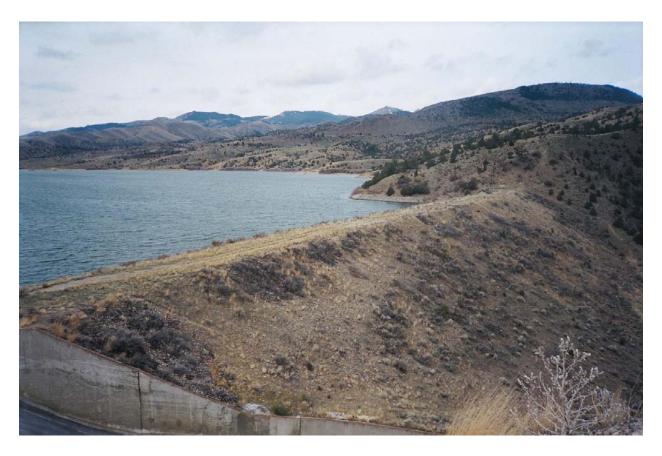
- Severe concrete deterioration exists in the spillway floor and walls. Spillway replacement is needed to correct the deficiencies.
- Excessive seepage may threaten the structural integrity of the spillway.

- A feasibility study to evaluate the problems at Ruby Dam at Ruby Dam was completed in 2007 by HLM Engineering of Billings . The \$285,000 feasibility study cost was authorized by the 2006 Legislature and paid by the DNRC.
- This project is in need of major rehabilitation. The preferred alternative identified in the feasibility study for rehabilitation, which includes a new spillway, outlet conduit, drains, access road and additional storage that could be marketed for beneficial uses, will bring the dam into full compliance with current safety and design standards and greatly reduce the state's liability.
- The proposed rehabilitation will also allow for future hydropower development.
